# Manhole Inspection Summary

Manhole # S23E1\_016MH

Insp Date: **11/20/08 9:49 AM**

**Location** Address: **2601 Waterview Ave.**

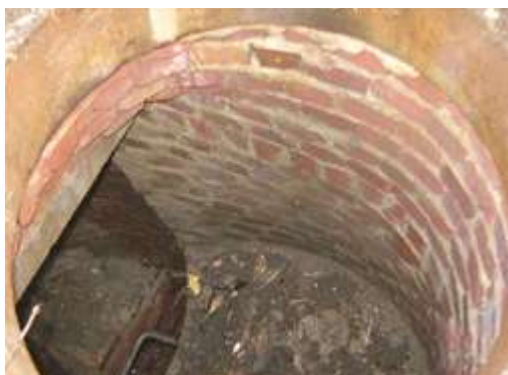
Defect 2

view of manhole

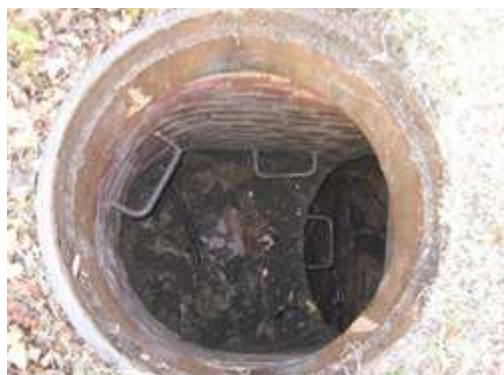
Defect 4

☒ **Leaks**

offset, frame leaks

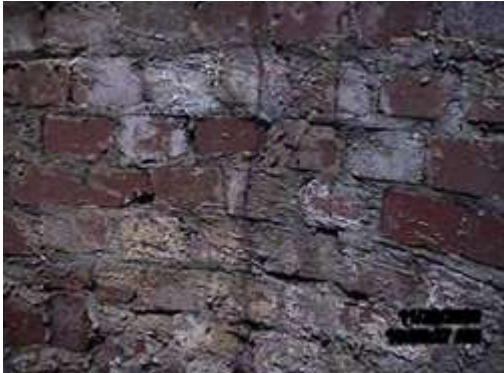
### Defect 1

Infiltration: ☐ None ☐ Joint ☐ Cracks ☒ **Mortar** ☐ Roots ☐ Wall

barrel infiltration

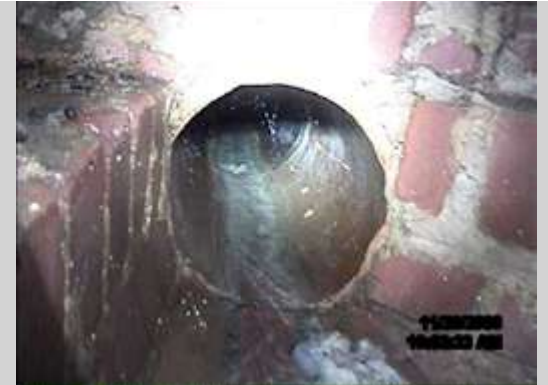
12 O'Clock Outflow

8 in. Circular Gravity Sewer  
Pipe Out @ 12 O'Clock

Pipe Height: **3.6** (in.) Rod and Bar (Angled)

Pipe Material: **Clay** ☐ Pipe Lined

Infiltration: **None** Pipe Seal Cond: **Sound**

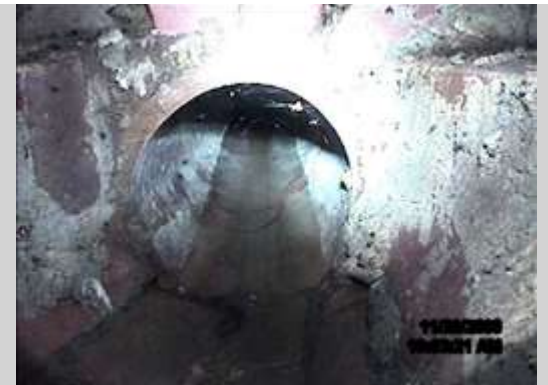
3 O'Clock Inflow

0 in. Circular Gravity Sewer  
Pipe In @ 3 O'Clock

Connects To: **Dead End**

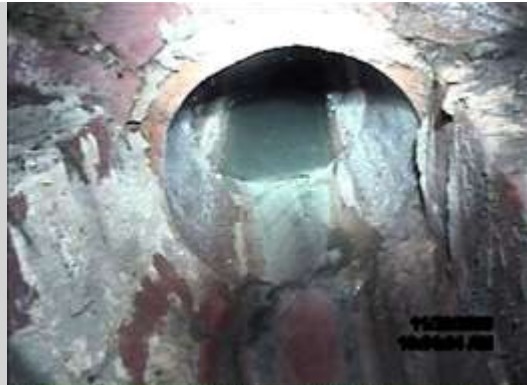
6 O'Clock Inflow

0 in. Circular Gravity Sewer  
Pipe In @ 6 O'Clock

Connects To: Manhole
